**FIRE RESEARCH AND DEVELOPMENT TECHNICAL REPORT**

# UL 9540A Installation Level Tests with Outdoor Lithium-ion Energy Storage System Mockups

*April 12, 2021*

## UL 9540A INSTALLATION LEVEL TESTS WITH OUTDOOR LITHIUM-ION ENERGY STORAGE SYSTEM MOCKUPS

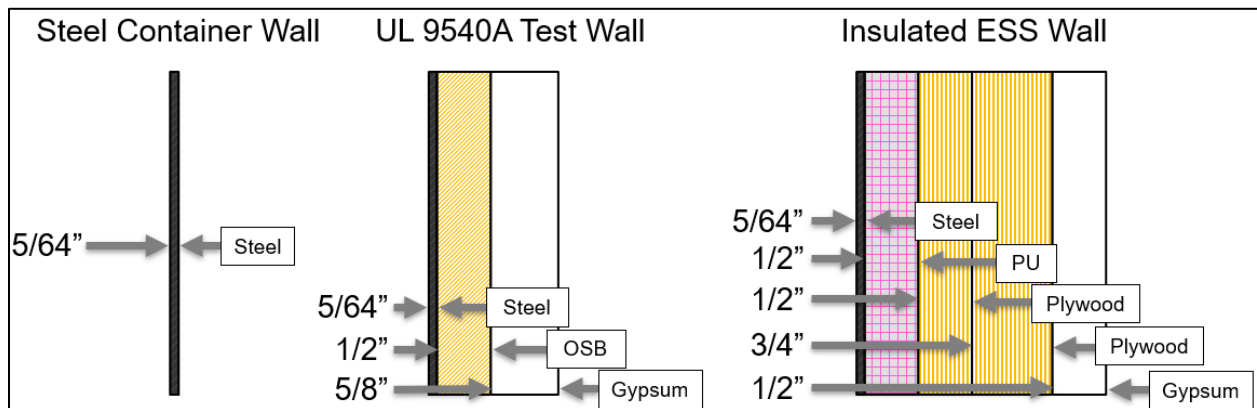
Figure 2 – Wall construction details, cross-section view.

Three different types of wall construction were built up over the container walls, as detailed in Figure 2. The different wall constructions were designed to enable comparison of internal and external temperature measurements with thermal imaging, and associated impact on incident size-up considerations. The three different wall constructions represent different interior finish configurations observed through UL’s experience testing commercial ESSs. Figure 3 through Figure 7 illustrate the locations of each wall construction type within the container.

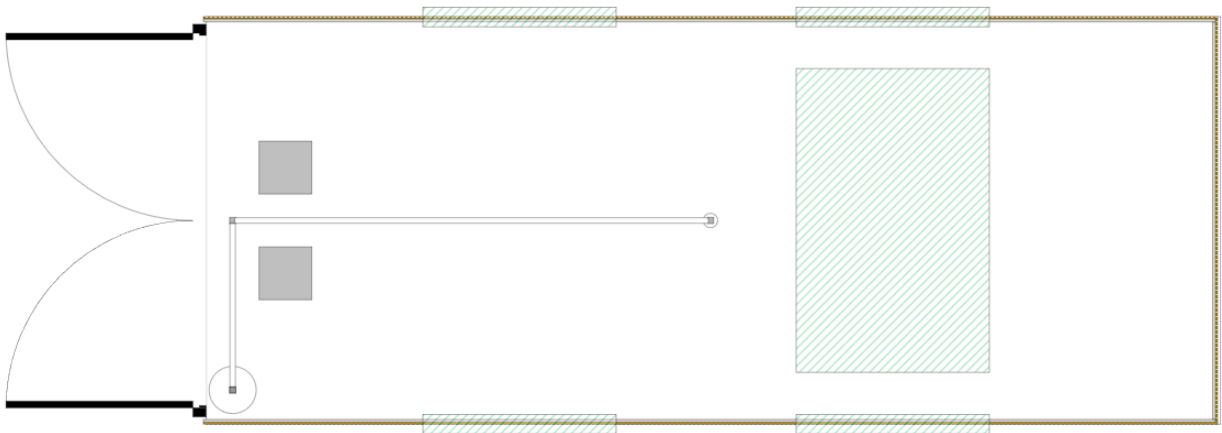
Figure 10 – Clean agent piping system to a central discharge nozzle, plan view.

The clean agent suppression system was conservatively designed for a Novec 1230 concentration of 8.0 v%, based on minimum agent design concentrations of 6.2 v% to 6.7 v% determined from cup burner tests of battery electrolytes [8]. The clean agent distributor developed a piping system design to achieve the design concentration of 8.0% for a 1,216 ft<sup>3</sup> protected design volume over a discharge time of 7.5 seconds, per NFPA 2001 requirements [9]. The final measured container volume was 1,169 ft<sup>3</sup>, resulting in a delivered concentration of approximately 8.3%. The discharge nozzle (Figure 12), Fike model #80-124-125-X, was located in the center of the container. The nozzle was designed with a 360° discharge pattern and was connected with the 1¼ in schedule 40 steel piping in a layout documented in Figure 10 and Figure 11. One 1 ft<sup>2</sup> positive pressure relief vent and one 1 ft<sup>2</sup> negative pressure relief vent were installed as pictured in Figure 13. The vents were installed to relieve positive and negative pressures imposed by discharging the clean agent system to prevent damage to the relatively low static activation pressure deflagration vent panels. The vents were engineered using the Guide to Estimating Enclosure Pressure and Pressure Relief Vent Area for Applications Using Clean Agent Fire Extinguishing Systems, 3rd edition [10]. The positive pressure vent was held closed under approximately 1lb weight loaded in the center of the panel. The negative pressure vent was pulled closed using a 5lb weight and a cable pulley system, attached to the center of the panel. The actuation pressures were 0.01 psig and 0.03 psig, respectively.

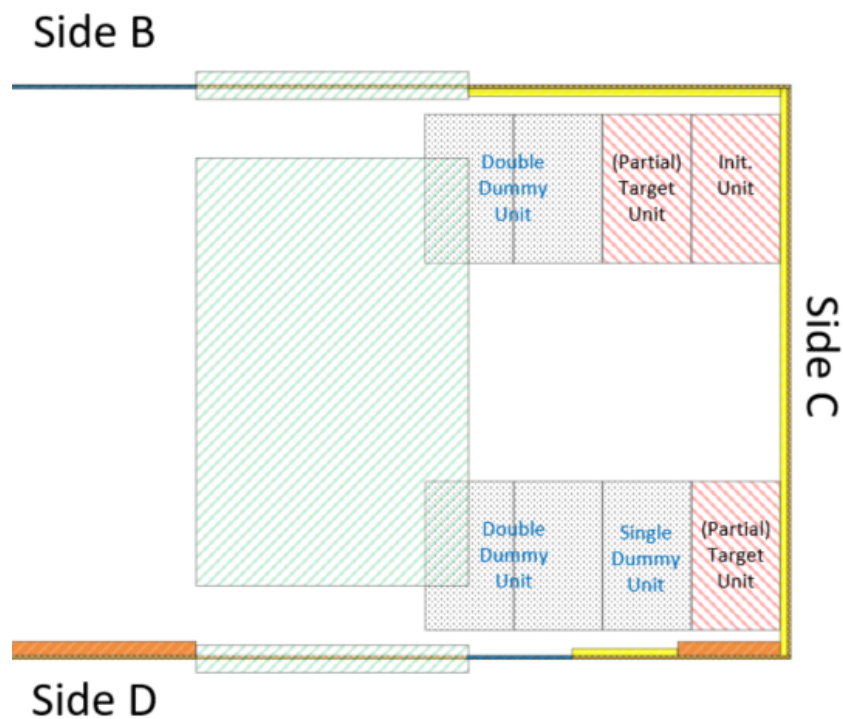
**Figure 22 – Initiating unit and target unit spacing.**

Per the guidelines of UL 9540A 4<sup>th</sup> edition, one complete unit charged to 100% was positioned as the Initiating Unit. The Initiating Unit was placed in a corner next to two instrumented walls and two instrumented Target Units. Next to the Target Units, dummy units were placed to represent realistic obstructions and installation conditions. There was 0 in of spacing between the Initiating Unit and the Left Target Unit, as well as the side instrumented wall. The Initiating Unit was placed with 3 in of clearance between the unit and the back instrumented wall. The Front Target Unit was placed across from the Initiating Unit, separated by a 35 in aisle, as summarized in Table 4. The installation is described in Figure 22 and pictured in Figure 23.

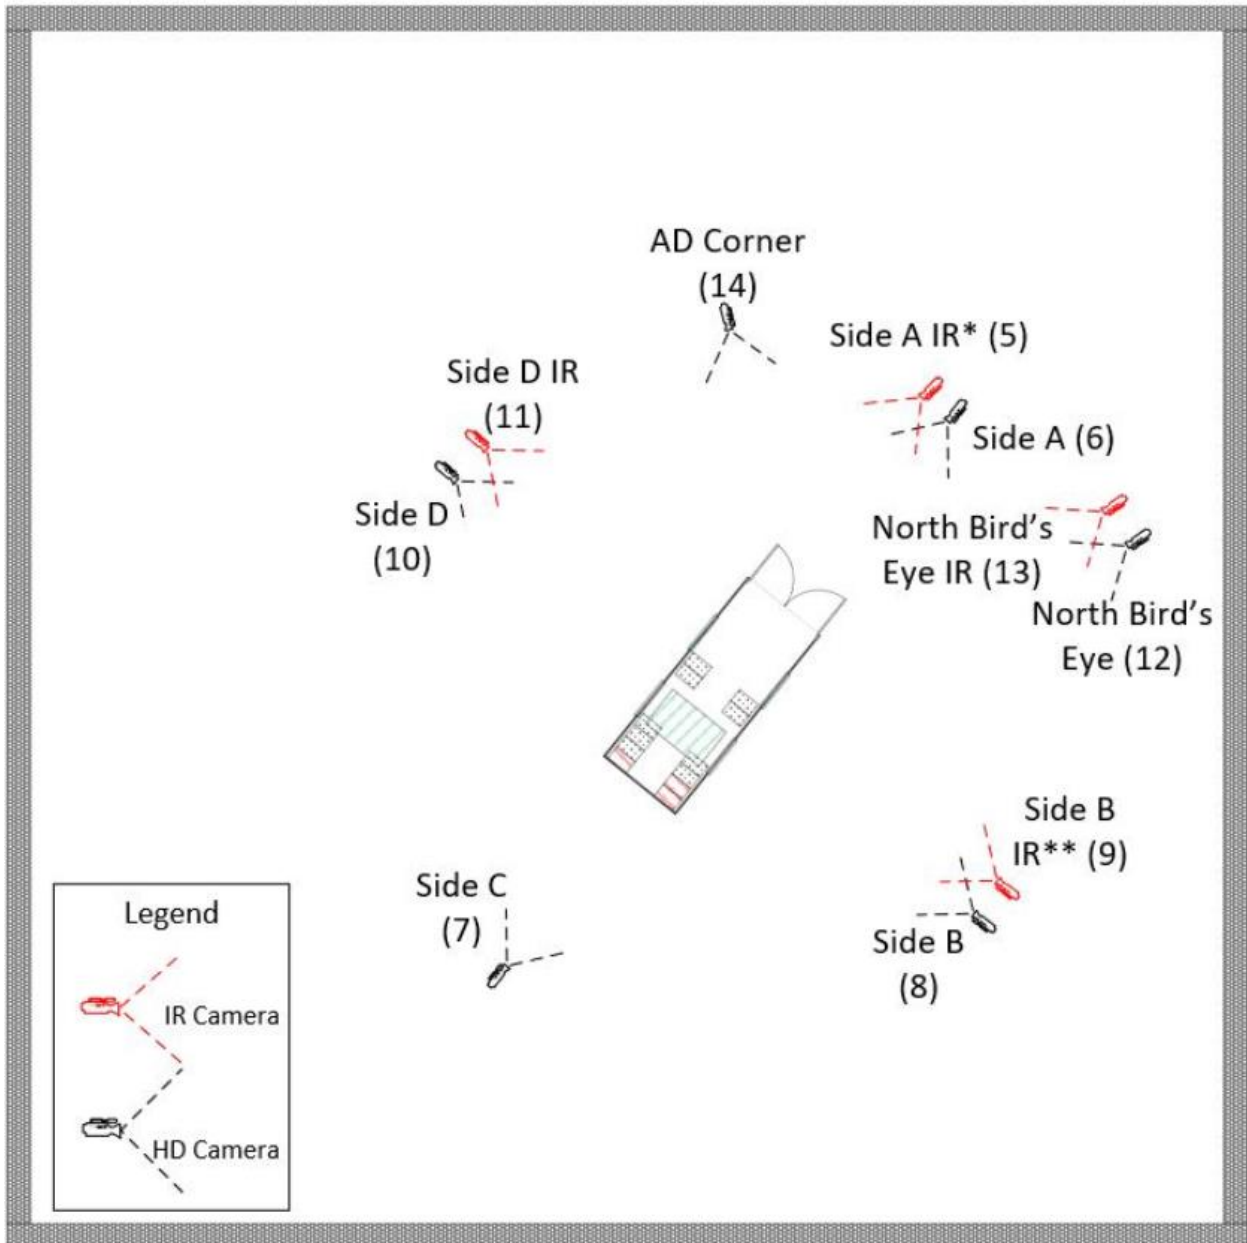
Figure 31 – Exterior camera locations.

Thermal imaging and high-definition (HD) cameras were located both inside and outside the container to monitor test conditions and capture visual cues for fire service size-up considerations. Figure 31 and Figure 32 show the camera locations on the interior and exterior of the container, respectively. The cameras are numbered according to the convention in Table 9.

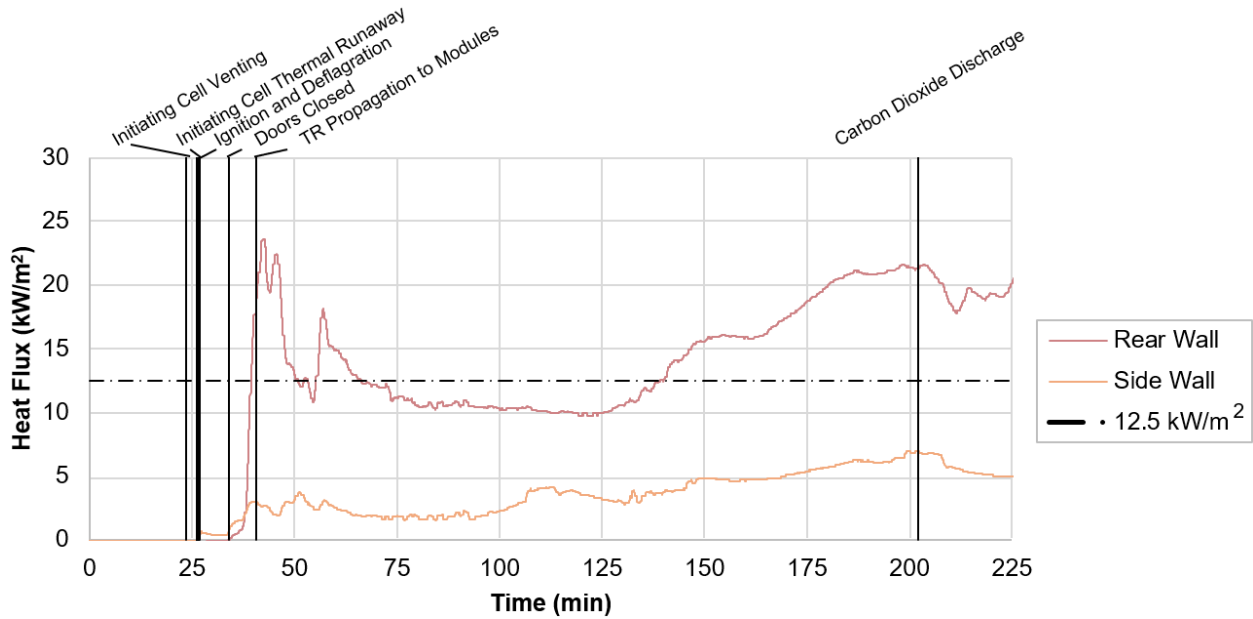
**Figure 38 – Incident heat fluxes to rear and side walls measured in Test 1.**

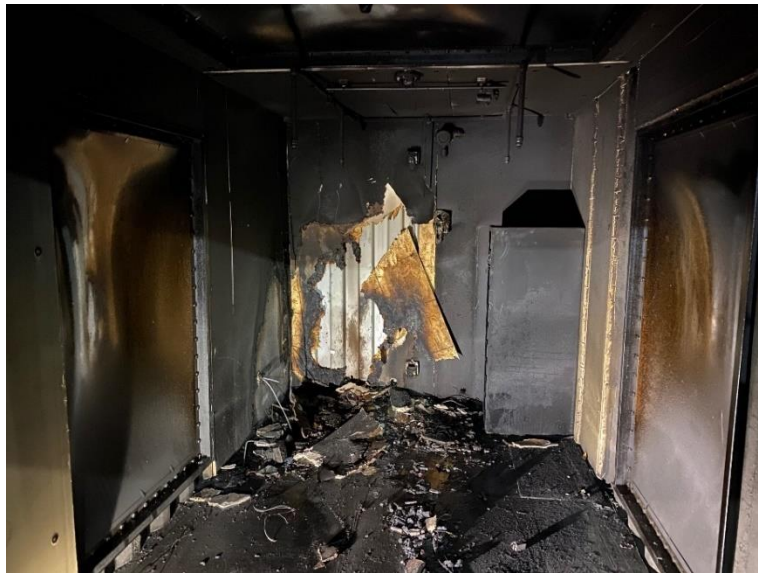
**Figure 39 – Thermal damage to walls photographed during test termination and overhaul after Test 1.**

During overhaul of the test, the ESS units were moved aside to reveal the condition of the instrumented walls, as shown in Figure 39. The paper coatings were burned off both walls. Both walls were charred. The plywood layer beneath the gypsum board on the side wall was smoldering with damage penetrating to the bare steel behind the plywood.

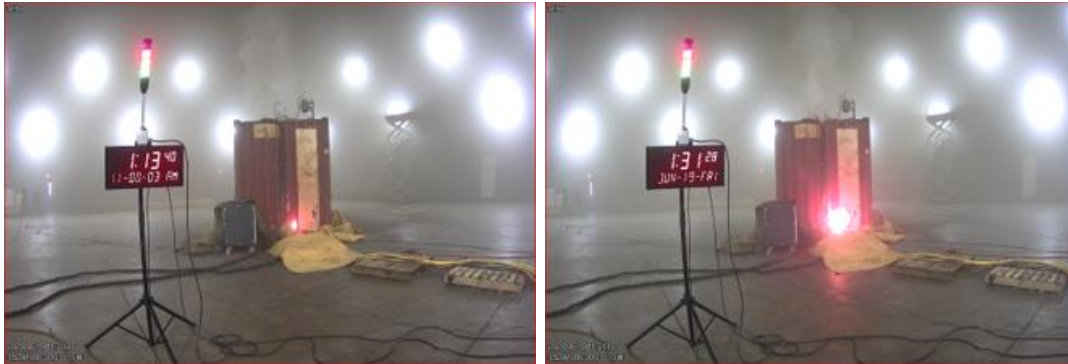
**Figure 43 – Flaming outside the test container through cable conduit in Test 1.**

Intermittent flaming of gases escaping from an instrumentation cable conduit in the container wall was observed, as pictured in Figure 43. The intermittent flaming is an indication the gas mixture that accumulated inside the container lacked sufficient oxygen for complete combustion and may have been above the upper flammability limit (UFL).

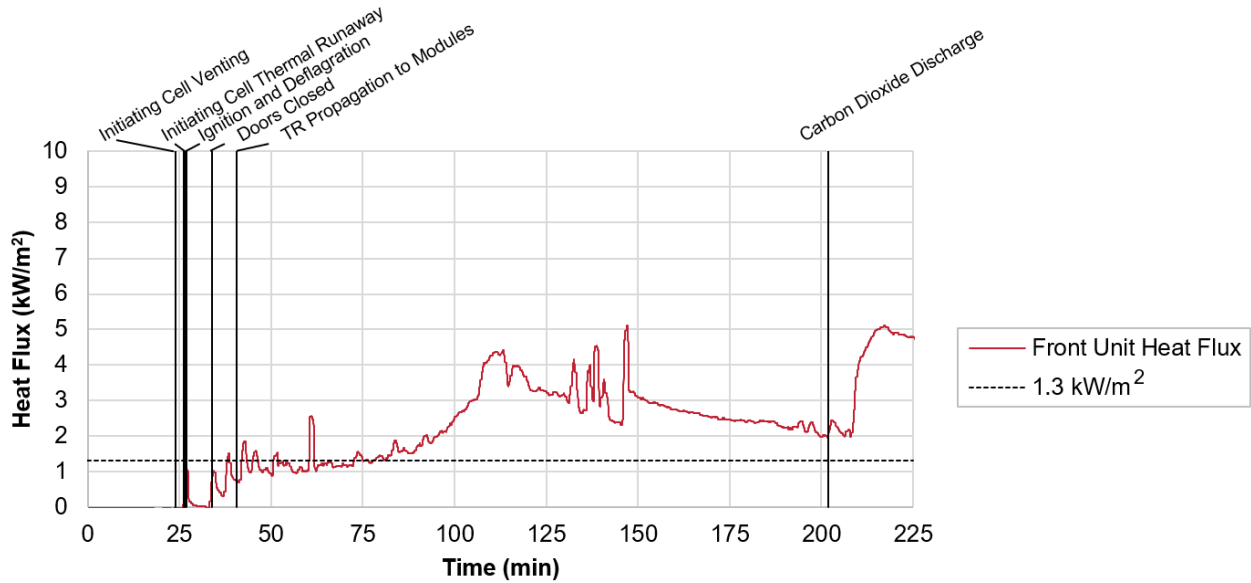
**Figure 44 – Heat flux measured in the egress path for Test 1.**

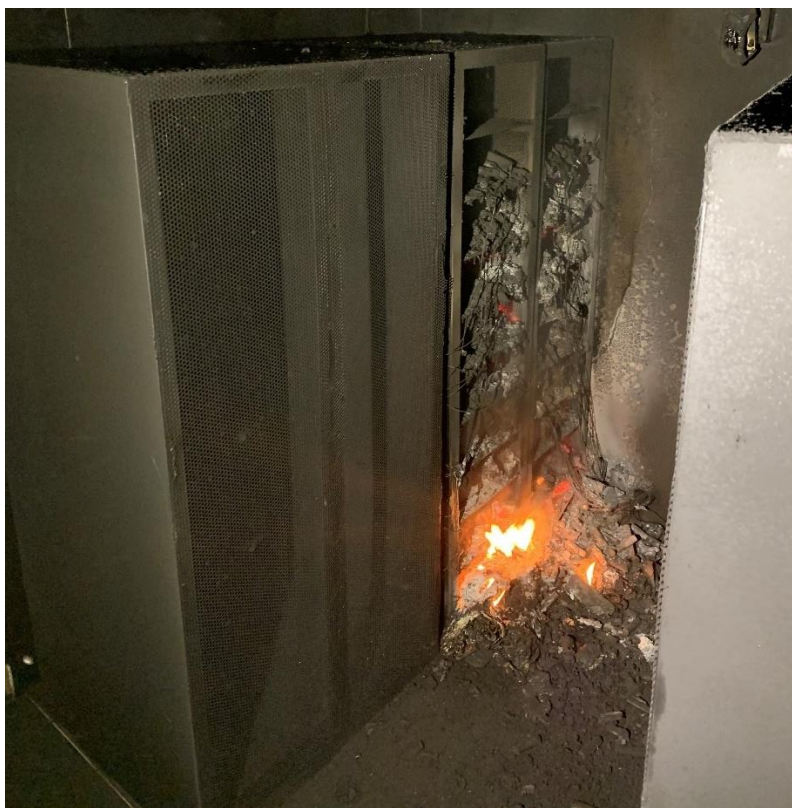
**Figure 46 – Re-ignited fire observed during overhaul of Test 1 (four hours after test start).**

A photo of the reignited mass of combustibles and cells is documented in Figure 46, which also illustrates the extent of thermal damage in Initiating, Left, and Front Target Units. All cells and most module materials were consumed in the Initiating and Left Target Units. The Front Target Unit shows soot deposition and some melting of module materials. Melted gas detectors positioned in the aisle demonstrated the thermal stress imposed on adjacent exposures.

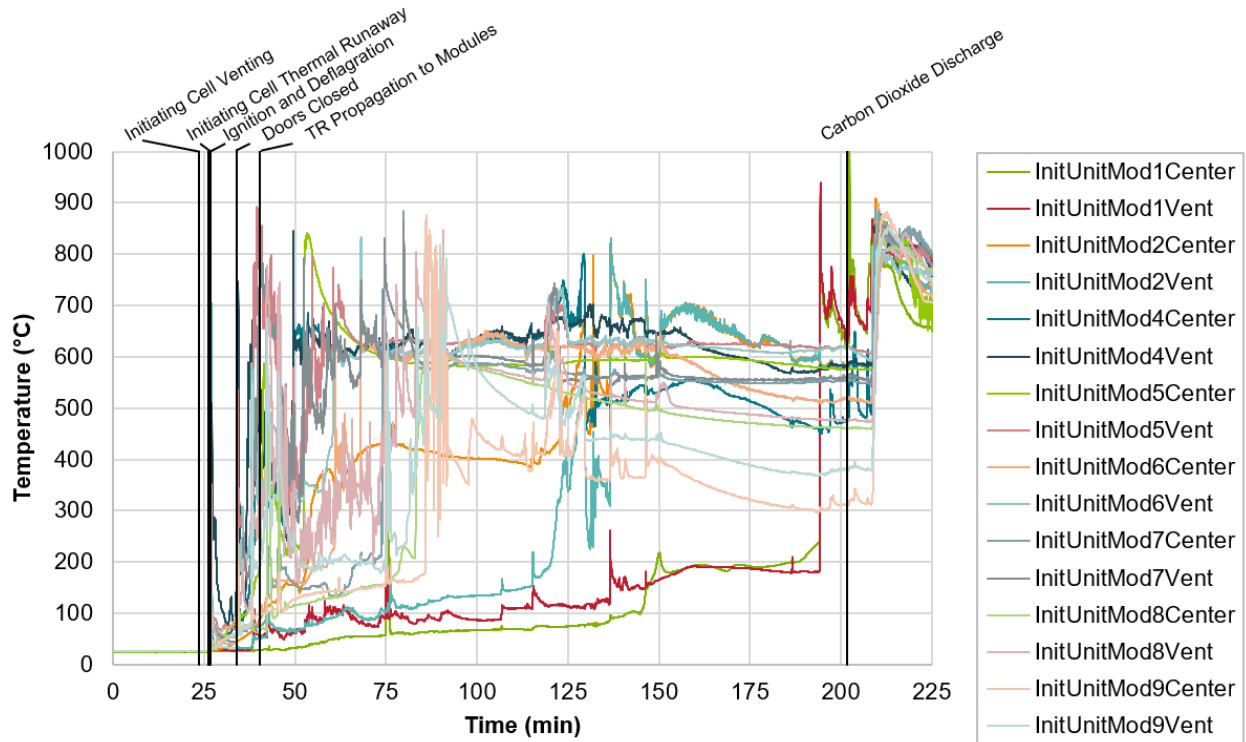
Figure 48 – Temperatures measured throughout the Initiating Unit during Test 1.

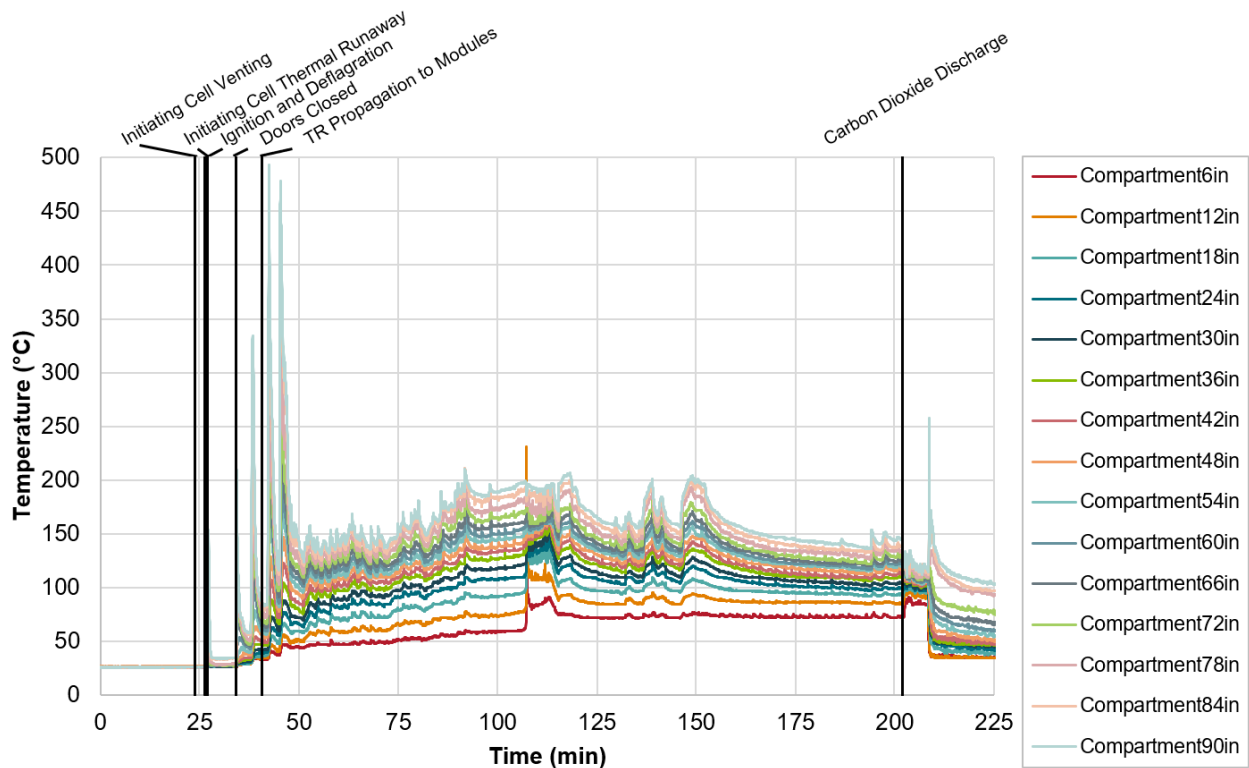
**Figure 50 – Container gas temperatures measured during Test 1.**

Gas temperatures measured in the center of the container increased rapidly when the container doors were shut after the partial volume deflagration. Once the container became under ventilated, flaming subsided and temperatures decreased. As more modules underwent thermal runaway, hot gases were vented from the modules into the container, resulting in temperatures ranging from 50 °C at the floor to 200 °C near the ceiling, as documented in Figure 50.

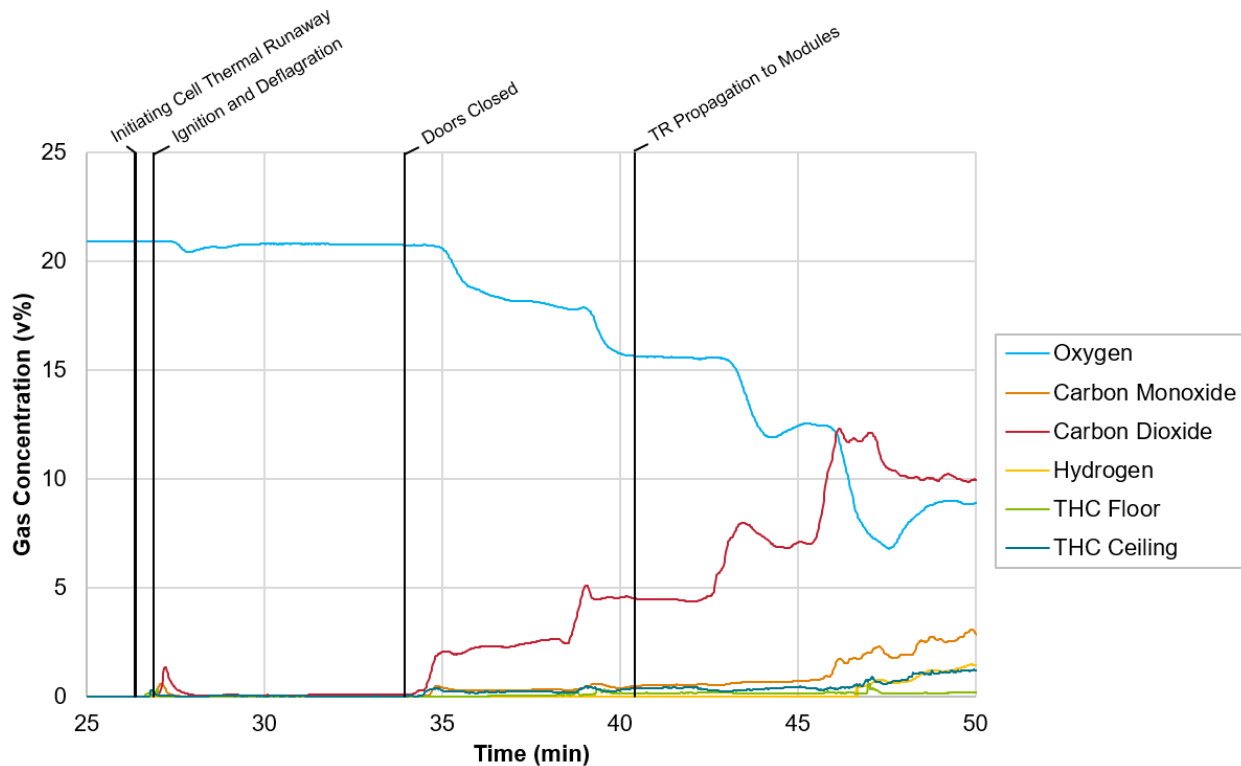
**Figure 51 – Gases measured in the container from thermal runaway through propagation of thermal runaway to other modules in Test 14.**

There was no indication of cell venting with the gas measurement instruments. After thermal runaway in the Initiating Cell, hydrocarbons were measured first and were followed by an increase in carbon monoxide and carbon dioxide concentrations, as shown in Figure 51. Hydrogen was not measured initially, though this is limited by a 0.4% concentration threshold applied within the meter.

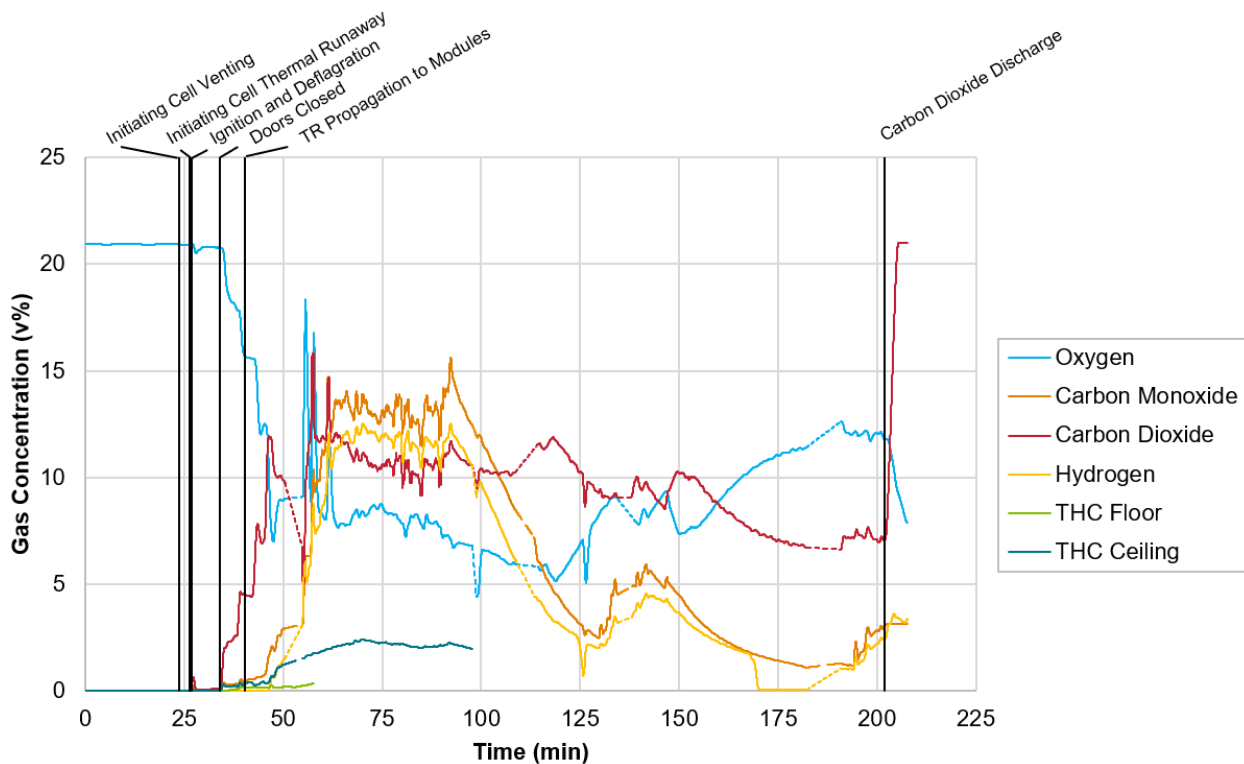
Figure 52 – Gas conditions measured in the container for the duration of Test 1<sup>5</sup>.

Between 60 and 90 minutes, a quasi-steady state condition was reached, as illustrated in Figure 52. Carbon dioxide, carbon monoxide, and hydrogen were all measured between 10 v% and 15 v%. At these concentrations, the atmosphere inside the container was comprised of 40–60 v% battery gas. Oxygen concentrations during this period were measured between 7 v% and 8 v%, corresponding to approximately 40% ambient air concentration by volume in the container. The upper flammability limit (UFL) of the battery gas is 40 v%, as was determined by ASTM E681 [25] during UL 9540A cell level testing. The majority of thermal runaway propagation activity subsided after 90 minutes. Between 90 minutes and 130 minutes, fresh air replaced battery gases as they leaked from the container, as illustrated by Figure 52. Increases in battery gas components were measured again near 130 minutes and 190 minutes, corresponding to thermal runaway events in Module 2 and Module 1. The decreasing concentration of battery gas and increasing concentration of oxygen demonstrates significant potential for flammable mixtures and a subsequent deflagration hazard. When the carbon dioxide system was discharged during test termination procedures, carbon dioxide concentration displaced other major gas components and enabled remote opening of the container doors with minimal risk of deflagration.

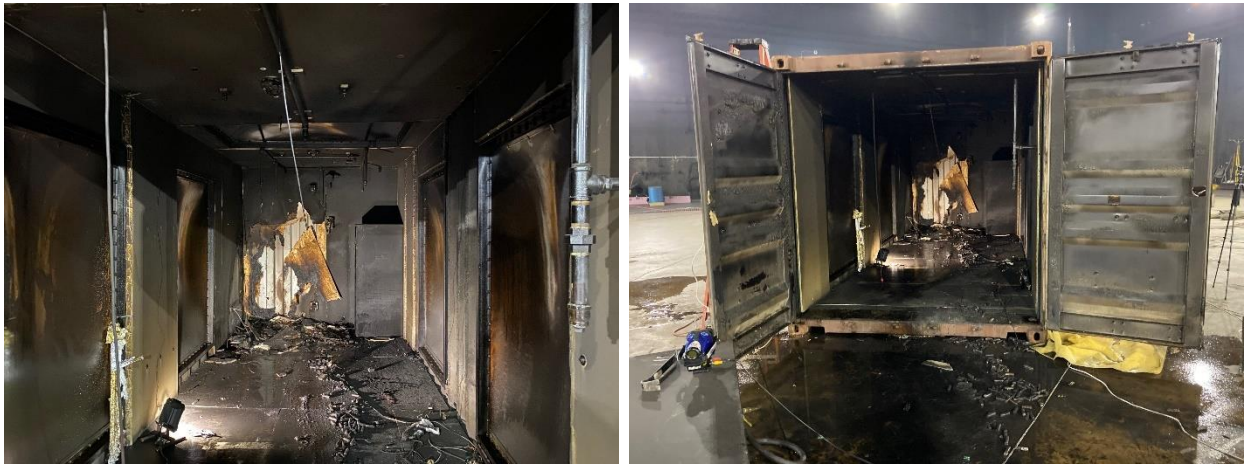
Figure 53 – Condition of container after Test 1 overhaul.

Thermal damage was limited primarily to the proximity of the Initiating and Left Target Units. The oriented strand board underneath the gypsum board and adjacent to the Initiating Unit was charred through its full thickness, as pictured in Figure 53. Some paper pyrolyzed off the gypsum wall board in a larger area, but most other apparent damage is actually soot deposition. All surfaces experienced heavy soot deposition, with the thickest layer of soot observed on the floor.

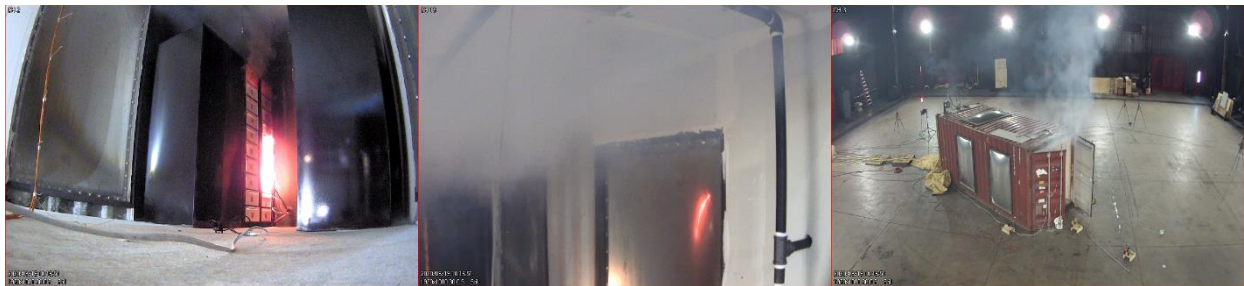
Figure 54 – Smoke layer condition upon activation of both smoke detectors in Test 1.

Neither smoke detector alarmed prior to the partial volume deflagration. The smoke detector nearest the Initiating Unit alarmed 46 seconds after the first thermal runaway event. The smoke detector located further from the Initiating Unit alarmed one second later. Figure 54 shows the thickness of the smoke layer at the time of smoke detector activation.

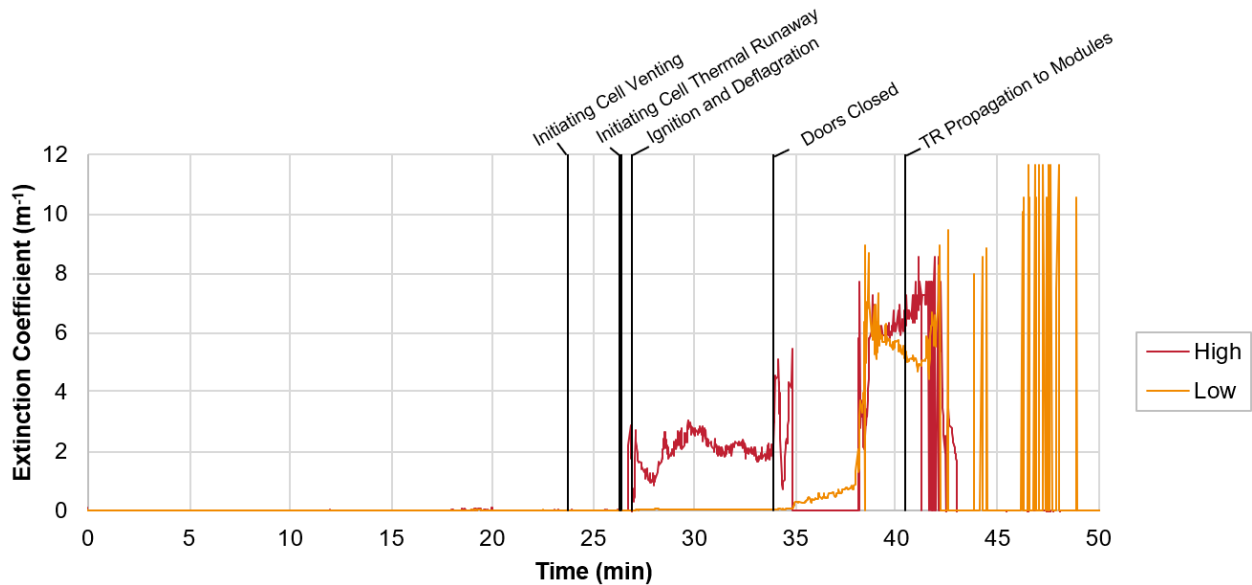
level following ignition. When the door was closed after the deflagration, smoke obscuration continued to increase at the ceiling until flaming subsided. As the smoke layer lowered, obscuration was measured at the lower instrument location. A sharp spike is observed near 36 minutes when thermal runaway propagates through the Initiating Module and the container is filled with thermal runaway gases and particulate.

**Figure 55 – Extinction coefficient measurements made by smoke obscuration meter for Test 1 from the beginning of the test through the propagation of thermal runaway to additional modules.**

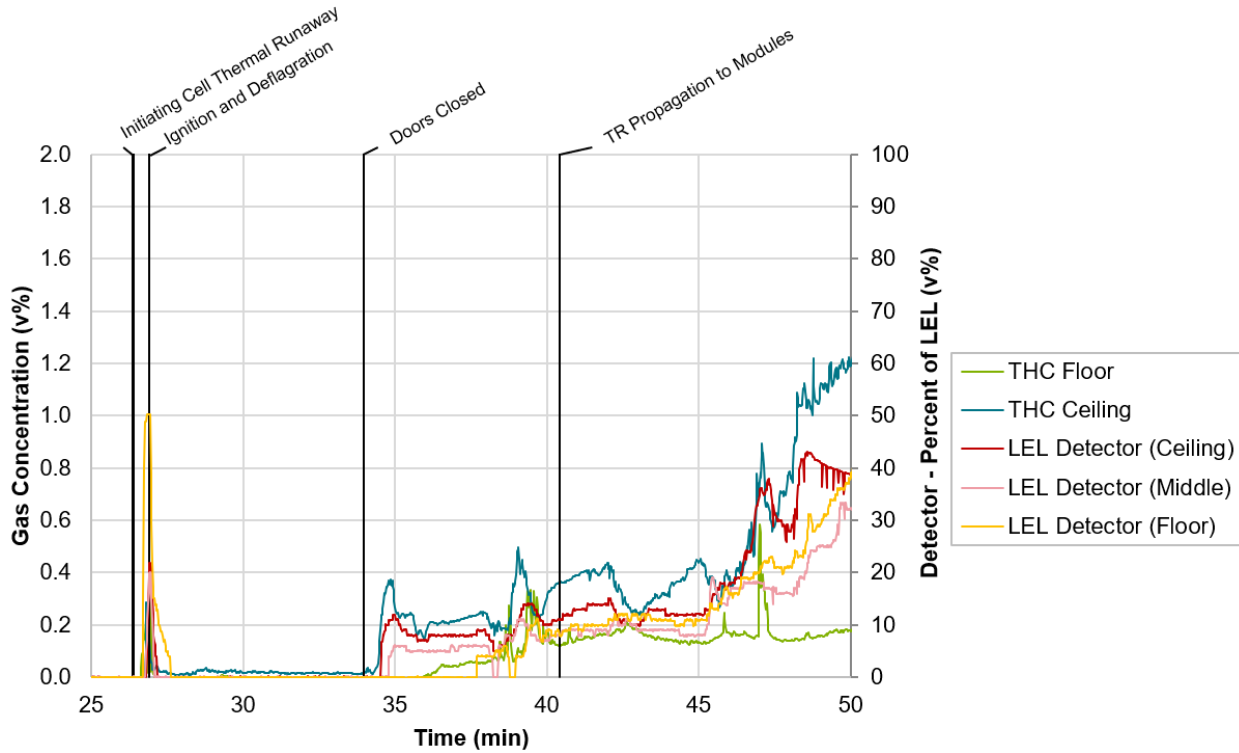
**Figure 57 – Total hydrocarbon concentration compared with commercial combustible gas detector response in Test 1 (test time 00:25:00 to 00:50:00).**

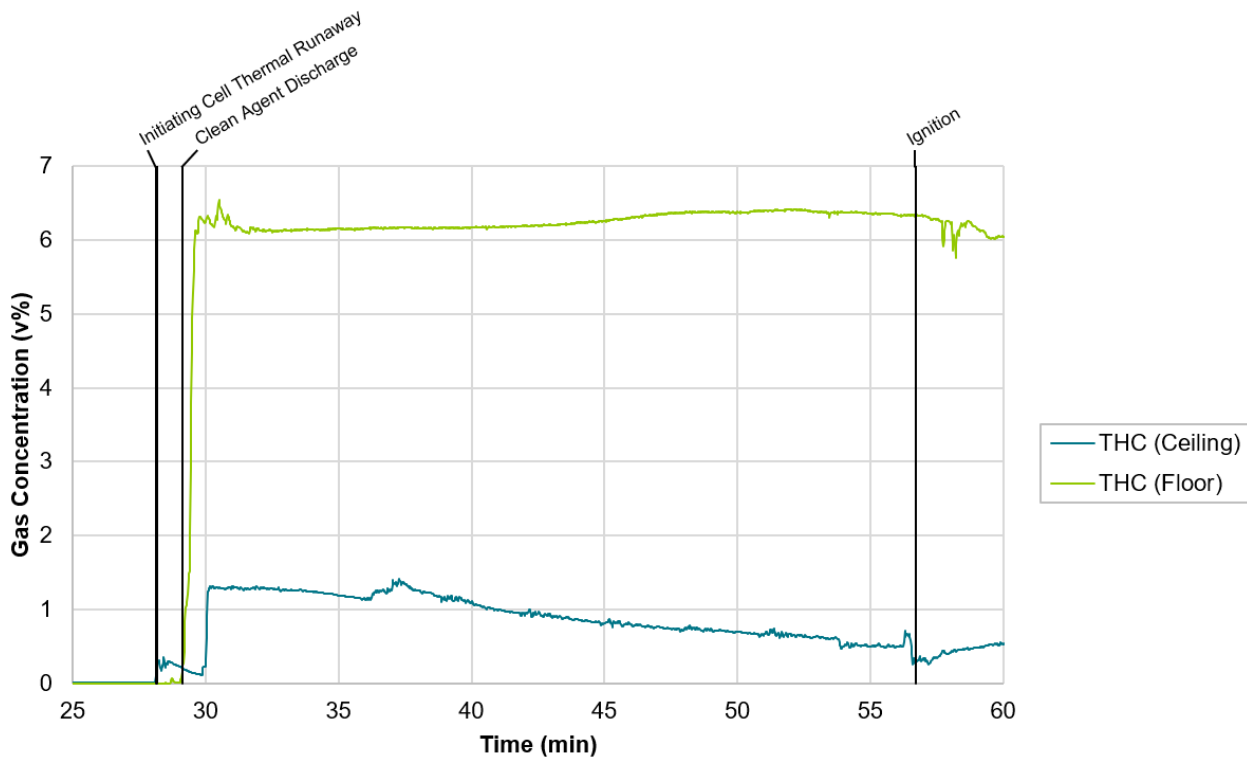
**Figure 104 – THC measurements at floor and ceiling after Novec 1230 deployment show progressive stratification in Test 2.**

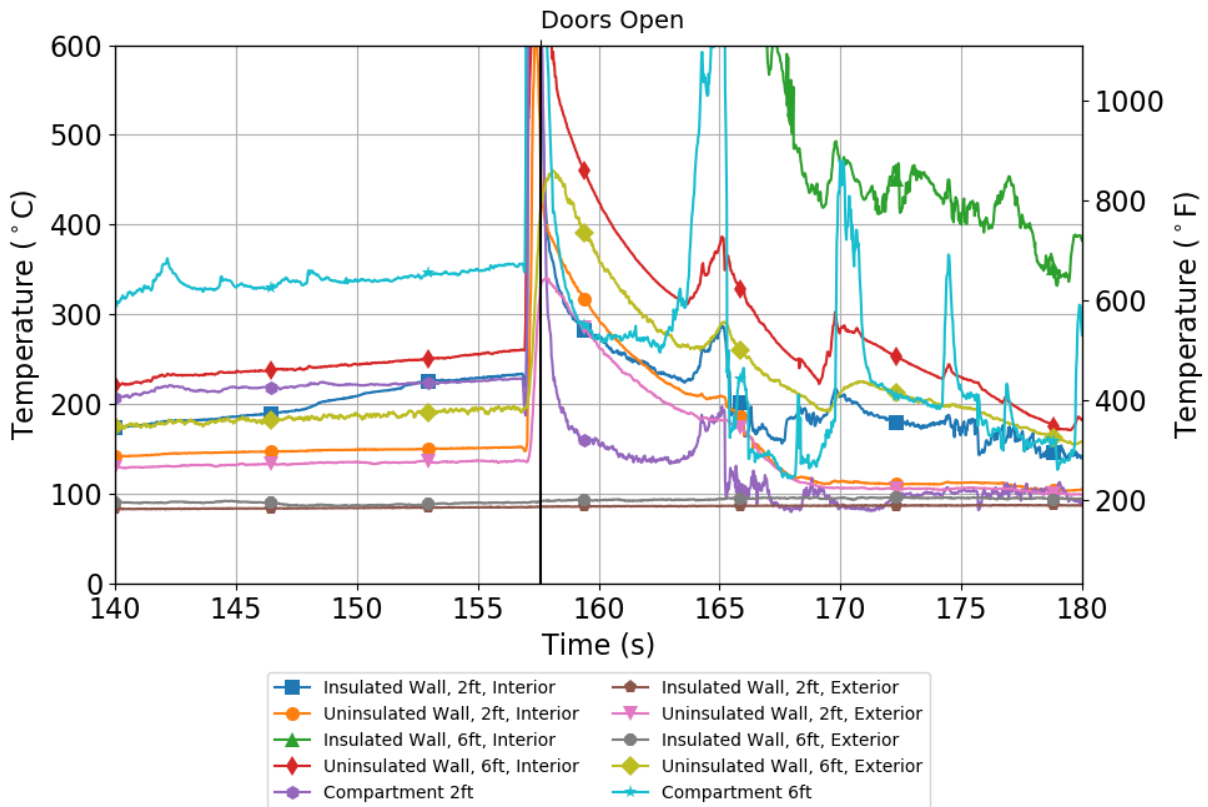
**Figure 111 – Wall surface temperatures during the period before and after the container doors were opened in Test 2. Vertical lines denote events corresponding to the images in Figure 112 below.**

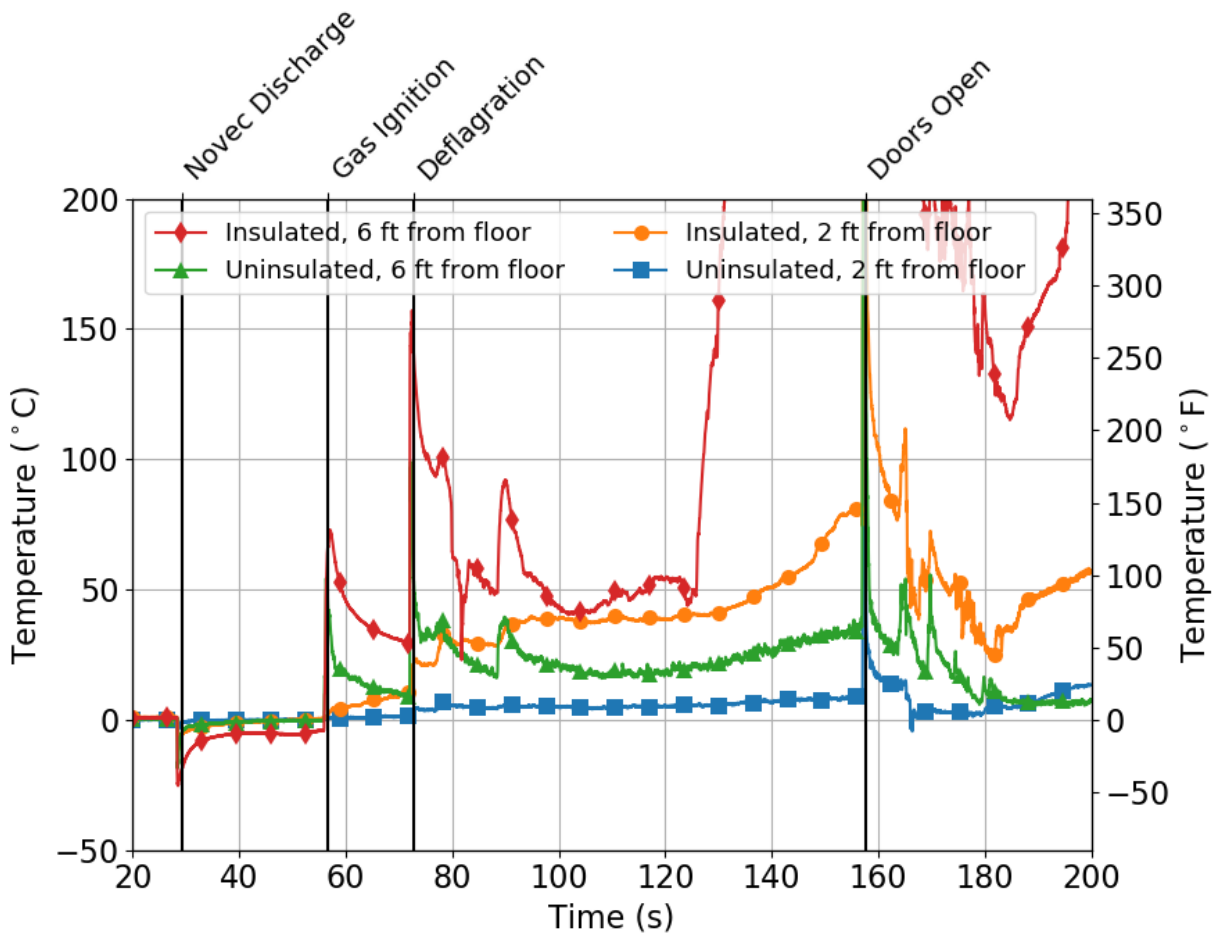
**Figure 113 – Temperature difference between inside and outside surface of container during Test 2.**

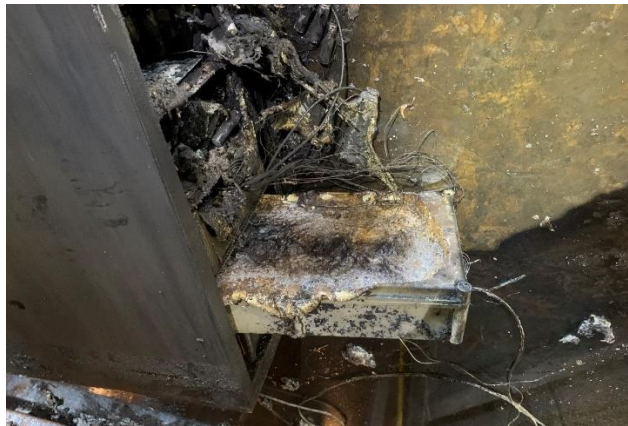
**Figure 139 – Condition of InitUnitMod2 with waterline visible after Test 3.**

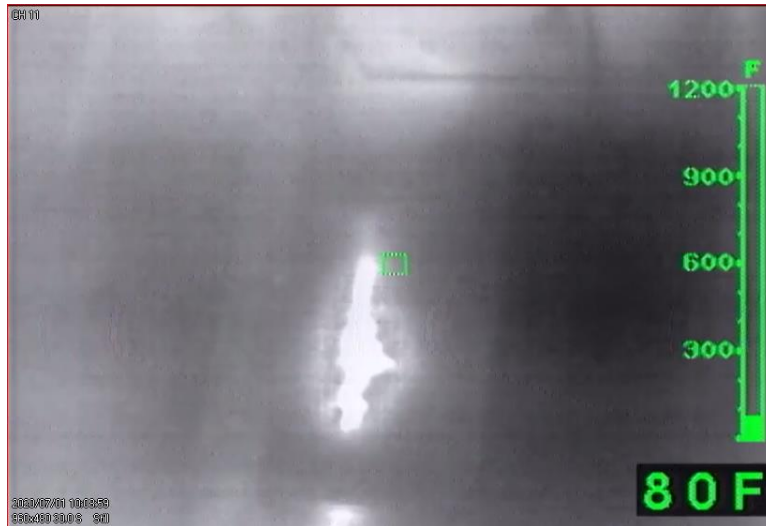
Figure 144 – Snapshot of thermal imaging camera facing the Initiating Unit suggesting additional off-gassing or flaming (test time 00:54:06).

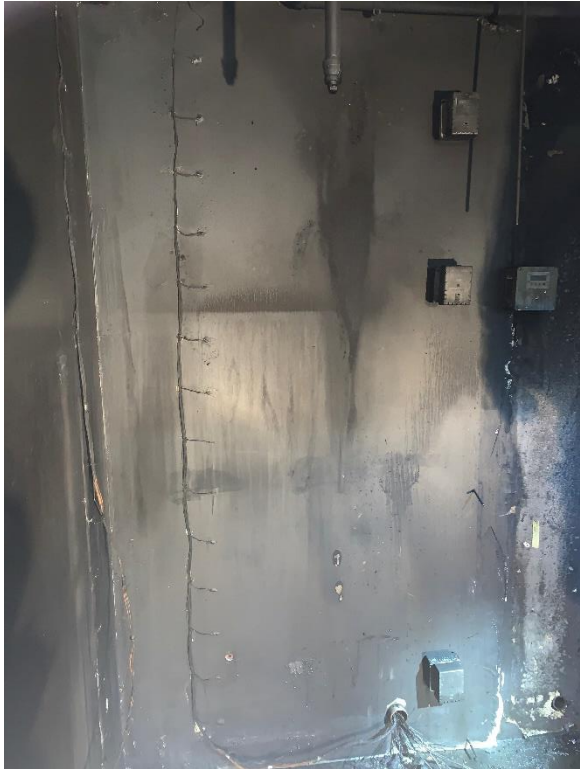
**Figure 145 – Condition of side wall next to the Initiating Unit after Test 3.**
