# Analysis of Changing Residential Fire Dynamics and Its Implications on Firefighter Operational Timeframes

*Stephen Kerber\**, UL, LLC, 333 Pfingsten Rd., Northbrook, IL 60062, USA

**Abstract.** There has been a steady change in the residential fire environment over the past several decades. These changes include larger homes, different home geometries, increased synthetic fuel loads, and changing construction materials. Several experiments were conducted to compare the impact of changing fuel loads in residential houses. These experiments show living room fires have flashover times of less than 5 min when they used to be on the order of 30 min. Other experiments demonstrate the failure time of wall linings, windows and interior doors have decreased over time which also impact fire growth and firefighter tactics. Each of these changes alone may not be significant but the all-encompassing effect of these components on residential fire behavior has changed the incidents that the fire service is responding to. This analysis examines this change in fire dynamics and the impact on firefighter response times and operational timeframes.

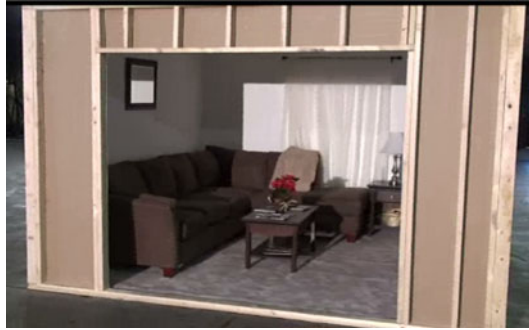
**Figure 4. Experiment 1 setup.**

The first set of rooms was 3.7 m by 3.7 m. The modern room (Experiment 1) was lined with a layer of 12.7 mm painted gypsum board and the floor was covered with carpet and padding (Figure 4). The furnishings included a polyester microfiber covered polyurethane foam filled sectional sofa, engineered wood coffee table, end table, television stand and book case. The sofa had a polyester throw placed on its right side. The end table had a lamp with polyester shade on top of it and a wicker basket on its lower shelf. The coffee table had six color magazines, a television remote and a synthetic plant on it. The television stand had a color magazine and a 37 inch flat panel television. The book case had two small plastic bins, two picture frames and two glass vases on it. The right rear corner of the room had a plastic toy bin, a plastic toy tub and four stuffed toys. The rear wall had polyester curtains hanging from a metal rod and the side walls had wood framed pictures hung on them (Figure 5).

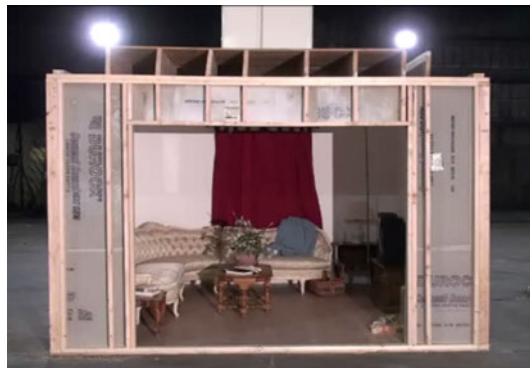
**Figure 6. Experiment 2 setup.**

The legacy room (Experiment 2) was lined with a layer of 12.7 mm painted cement board and the floor was covered with unfinished hardwood flooring (Figure 6). The furnishings included a cotton covered, cotton batting filled sectional sofa, solid wood coffee table, two end tables, and television stand. The sofa had a cotton throw placed on its right side. Both end tables had a lamp with polyester shade on top of them. The one on the left side of the sofa had two paperback books on it. A wicker basket was located on the floor in front of the right side of the sofa at the floor level. The coffee table had three hard-covered books, a television remote and a synthetic plant on it. The television stand had a 27 inch tube television. The right front corner of the room had a wood toy bin, and multiple wood toys. The rear wall had cotton curtains hanging from a metal rod and the side walls had wood framed pictures hung on them (Figure 7).

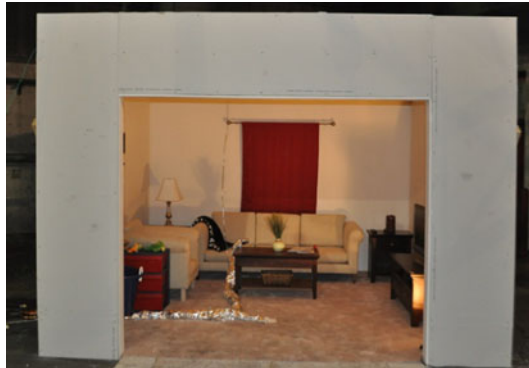
**Figure 8. Experiment 3 setup.**

The second set of rooms was also 3.7 m by 3.7 m with a 2.4 m ceiling and a 2.4 m wide by 2.1 m tall opening on the front wall. Both rooms contained identical furnishings with the exception of the sofa and the chair. The first room (Experiment 3) had a polyurethane foam filled sofa and chair with microfiber

fabric covering (Figures 8, 10). The second room (Experiment 4) had a cotton padded, innerspring sofa and chair with cotton cover fabric (Figures 9, 11). The contents were similar to those used in the first modern room. The floors were covered in polyester carpet over polyurethane foam padding. The contents included an engineered wood coffee table, two end tables, television stand and book case. The sofa had a polyester throw placed on its left side. The left end table had a lamp with polyester shade on top of it and the right end table had a television remote, candle and vase filled with synthetic rose pedals. The coffee table had four color magazines and a synthetic plant on it. The television stand had a 37 inch flat panel television. The book case had two baskets and a picture frame on it. The left side of the room had a plastic toy bin, a plastic toy tub and four stuffed

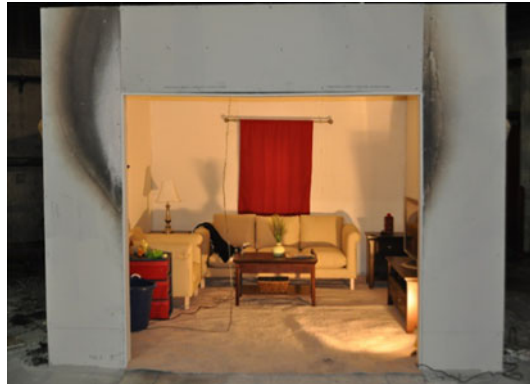
**Figure 9. Experiment 4 setup.**

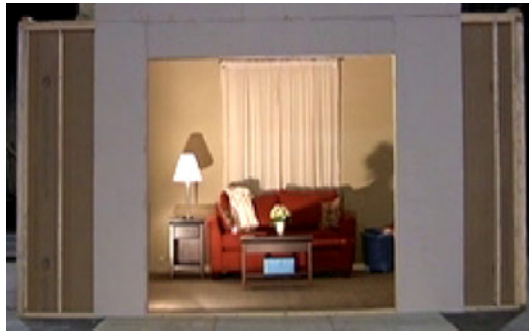
**Figure 12. Experiment 5 setup.**

The third set of rooms was larger and measured 4.0 m by 5.5 m. The modern room (Experiment 5) was lined with a layer of 12.7 mm painted gypsum board and the floor was covered with nylon carpet and polyurethane padding (Figure 12). The furnishings included a polyester microfiber covered polyurethane foam filled sofa, two matching chairs, engineered wood coffee table, end table, television stand and book case. The sofa had a polyester throw placed on its left side and two polyfill pillows, one on each side. The end table had a lamp with polyester shade on top of it. The coffee table had three color magazines, a wicker basket and a synthetic plant on it. The television stand had two picture frames

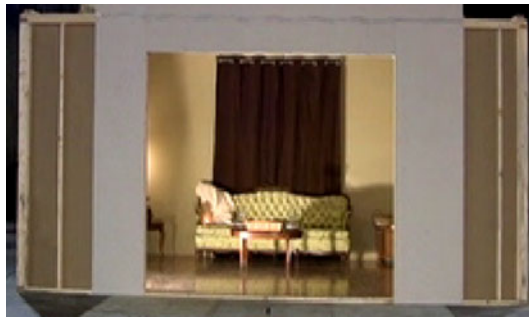
**Figure 14. Experiment 6 setup.**

The legacy room (Experiment 6) was lined with a layer of 12.7 mm painted gypsum board and the floor was covered with finished hardwood flooring (Figure 14). The furnishings included a cotton covered, cotton batting filled sofa, two matching chairs, solid wood coffee table, two end tables, and television stand. The sofa had a cotton throw placed on its left side. Both end tables had a lamp with glass shade on top of them and a wicker basket. The coffee table had a wicker basket filled with five books and two glass vases. The television stand had a 13 in

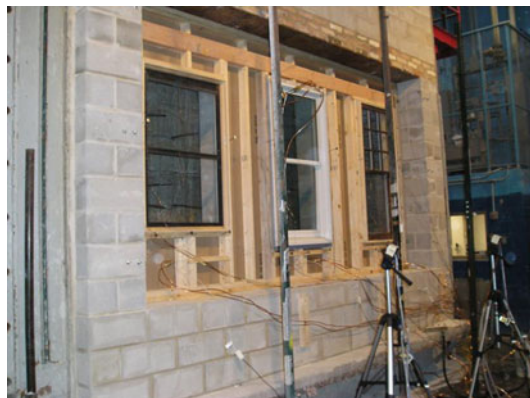
**Figure 20. Window experimental setup.**

Fire performance experiments were conducted to identify and quantify the self-ventilation performance of windows, comparing legacy to modern, in a fire event prior to fire service arrival (Figure 20). Different window construction parameters assessed include: (1) wood frame and vinyl frame construction; (2) single and multi-pane designs and (3) single and multi-glazed designs. Modern windows are defined as windows that are able to be easily purchased new and that are typically

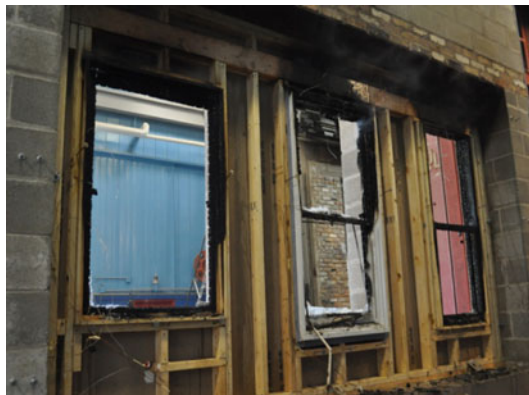
**Figure 21.** Windows after the experiment (middle window was modern).

There were a number of different window failure mechanisms and degrees of failure observed during the experiments. In order to have an impact on the fire growth there has to be a passage for air to enter the structure, therefore the failure of interest was the breaking out of the glass as opposed to the cracking of the glass. Failure is defined as a passage through the window of 25% or more of the total glass area. In most cases this was the failure of the top or bottom pane(s) of the window but in some cases the top window sash moved downward, opening the window 25% or more. The two legacy windows with single glazing failed later than the four modern windows with double glazing (Figure 21). The two legacy windows failed at 577 s and 846 s respectively while the modern windows failed at 259 s, 254 s, 312 s, and 270 s respectively (Table 5).

These experiments demonstrated a significant difference in legacy and modern windows exposed to fire conditions. In this series of experiments the legacy single glazed windows outperformed the modern double glazed windows in terms of longer failure times. It is proposed that this occurred for two reasons. First the legacy windows had thicker glazing than the modern windows. The legacy windows had glass thicknesses of 2.4 mm and 2.8 mm, while the modern window thicknesses were 2.2 mm. Second, the method the glass was fixed into the frame differed greatly between the two eras. The legacy window glass was held in place with putty like substance and there was room in the frame for expansion of the glass. The modern glass was fixed very tightly into the frame with an air tight gasket and metal band, to provide better thermal insulation. This configuration did not allow for much expansion and therefore stressed the glass as it heated and expanded.

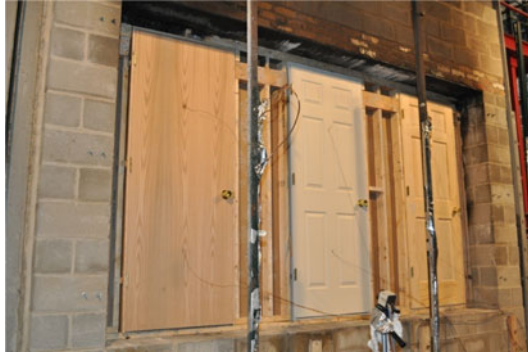
**Figure 22. Door samples prior to testing.**

*3.2.4. Interior Doors.* Much like structural components, doors have been changed from a solid slab of wood to an engineered approach where doors are made hollow to use less material. To examine the impact of this change on fire resiliency three different interior door designs were exposed to the panel furnace following the temperature curve specified in “Positive Pressure Fire Tests of Door Assemblies,” UL 10C, 2nd Edition dated January 26, 2009 [30]. Different door construction parameters assessed include: (1) Hollow and solid core construction; and (2) different wood types (Figure 22).

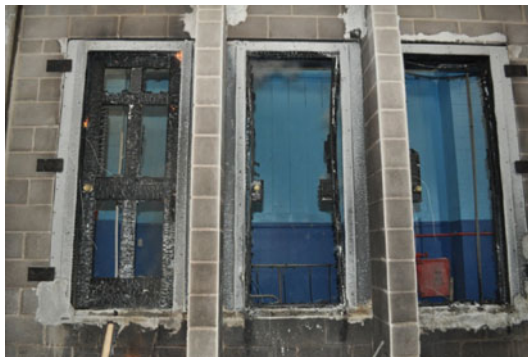
**Figure 23. Door samples after the test.**

The doors evaluated in this experiment demonstrated that the type of wood had no noticeable impact on failure time. The failure time was dictated by the thickness of the door. The hollow core doors had the same overall wood thickness as the panels of the solid core door and therefore the fire breached them at very similar times. Without the panels cut into the solid core door it would have lasted substantially longer as indicated by the amount of wood remaining in the post test analysis of the door.
